Contract #: 04-0120F4Cty: SF/ALA Rte: 80 PM: 13.2/13.9File #: 1.28**WELDING INSPECTION REPORT****Resident Engineer:**Siegenthaler, Peter**Address:** 333 Burma Road**City:** Oakland, CA 94607**Report No:** WIR-023702**Date Inspected:** 12-May-2011**Project Name:** SAS Superstructure**OSM Arrival Time:** 730**Prime Contractor:** American Bridge/Fluor Enterprises, a JV**OSM Departure Time:** 1600**Contractor:** American Bridge/Fluor Enterprises, a JV**Location:** Job Site**CWI Name:** N / A**CWI Present:** Yes No**Inspected CWI report:** Yes No N/A**Rod Oven in Use:** Yes No N/A**Electrode to specification:** Yes No N/A**Weld Procedures Followed:** Yes No N/A**Qualified Welders:** Yes No N/A**Verified Joint Fit-up:** Yes No N/A**Approved Drawings:** Yes No N/A**Approved WPS:** Yes No N/A**Delayed / Cancelled:** Yes No N/A**Bridge No:** 34-0006**Component:** S.A.S. components**Summary of Items Observed:**

WELDING INSPECTION REPORT

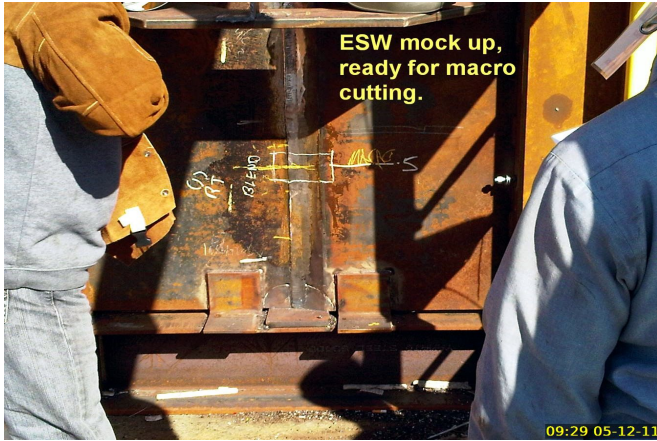
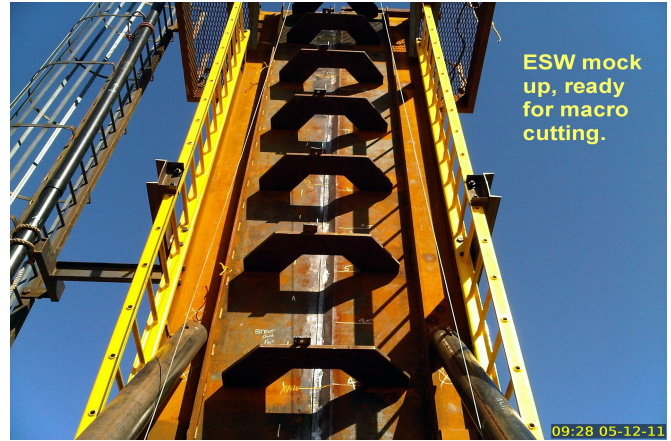
The QAI met with the QAI Robert Mertz and continued to conduct Ultrasonic Testing (UT) verification of the full height ElectroSlag Welding (ESW) weld trial (mock up). The QAIs noted that there are very minor indications that can be observed during the UT examination. The QAI noted that no rejectable indications were observed during the verification testing of the mock up. The QAIs marked out 6 locations where the contractor will cut coupons from the mock up in order to provide macro-etched specimens for examination. As the QAI completed the UT verification, the contractor's personnel began cutting the 150mm x 75mm sections from the mock up. See the attached photos.
